**Flood Control Project Maintenance
Levee Inspections****LMA District Cover Sheet****Spring 2014 Levee Inspection Results****Reclamation District No. 2103 Wheatland Vicinity**

Levee Inspection Report By Mile - Spring 2014

Reclamation District No. 2103 Wheatland Vicinity

Waterway	Bank	Unit Miles	Inspection Start/End	Inspector
Unit No. 01 South Dry Creek	Left	4.77	04/24/2014 04/24/2014	Matthew Hoffman

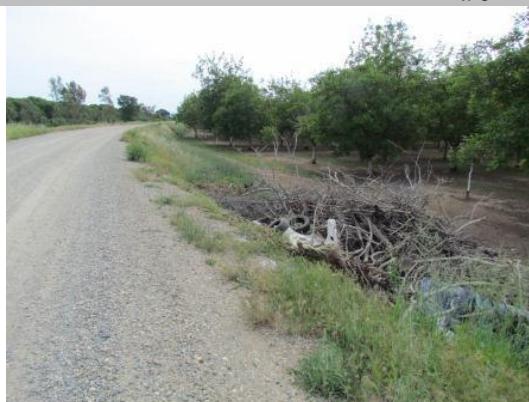
Photo 1 of 1 : mhoffman_s_20140428_484.jpg

LM Start	0.20	Rating **	M	Issue No.	13
LM End	0.20	Issue Type +	En	Location *	LS
Category	Earthen Levee			GPS Latitude/Longitude	
				Start	End
Item	Encroachments			39.020891 °	39.020891 °
				-121.450621 °	-121.450621 °
DWR ID	DWR_RD2103_01_s_2014_13				
Action/Comments					
Debris

This photo was taken from the levee crown facing east looking down the southern levee slope at a debris pile. Spring 2014.

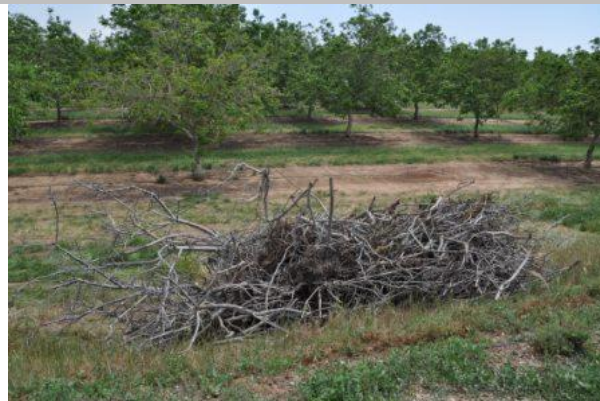
Photo 1 of 1 : mhoffman_s_20140401_284.jpg

LM Start	0.73	Rating **	M	Issue No.	4
LM End	0.73	Issue Type +	En	Location *	LS
Category	Earthen Levee			GPS Latitude/Longitude	
				Start	End
Item	Encroachments			39.022892 °	39.024105 °
				-121.444529 °	-121.442552 °
DWR ID	DWR_RD2103_01_s _ 2013_4				
Action/Comments					
Prunings					
Inspector Comments: Two pruning piles approx. 200ft apart on L/S slope.

L/S slope pruning pile.

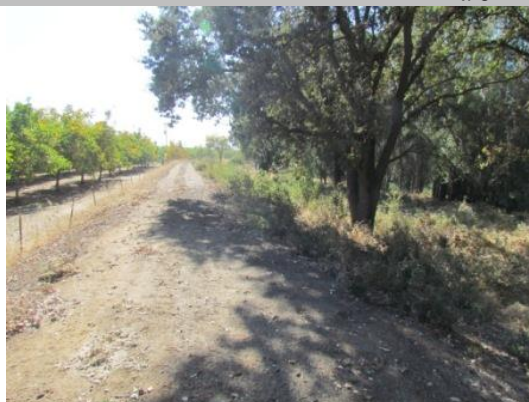
Photo 1 of 1 : mhoffman_s_20140401_285.jpg

LM Start	4.52	Rating **	M	Issue No.	8
LM End	4.58	Issue Type +	Ma	Location *	WS
Category	Earthen Levee			GPS Latitude/Longitude	
				Start	End
Item	Vegetation			39.041051 °	39.041810 °
				-121.394931 °	-121.393951 °
DWR ID	DWR_RD2103_01_f_2013_8				
Action/Comments					
Remove the wild growth other than native grasses from the levee slopes.

This photo was taken from the crown of the levee facing west looking at the vegetation on the waterward slope of the levee.

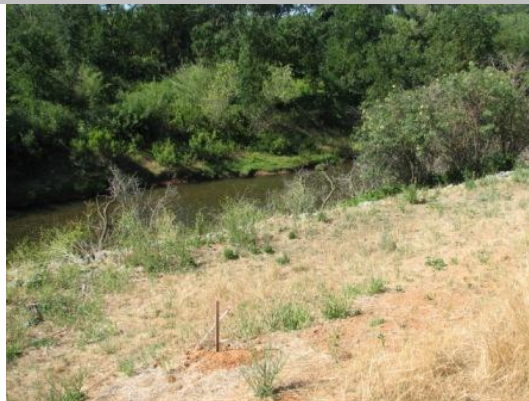
Photo 1 of 2 : mhoffman_s_20140401_287.jpg

LM Start	0.30	Rating **	A/W	Issue No.	4
LM End	0.51	Issue Type +	Ma	Location *	WS
Category	Earthen Levee			GPS Latitude/Longitude	
				Start	End
Item	Riprap Revetments			38.994660 °	38.995537 °
				-121.432170 °	-121.428535 °
DWR ID	DWR_RD2103_02_s_2012_4				
Action/Comments					
Inspector Comments: The District has a concern with dead trees placed in the rip rap that may not stay in place during a high water event.

Trees at waters edge in the rip rap levee mile 0.30.

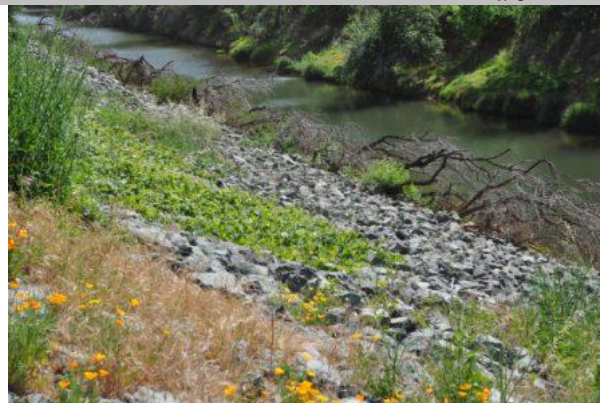
Photo 2 of 2 : mhoffman_s_20140401_288.jpg

LM Start	0.30	Rating **	A/W	Issue No.	4 (cont)
LM End	0.51	Issue Type +	Ma	Location *	WS

View of revetment with dead trees, Spring 2013.

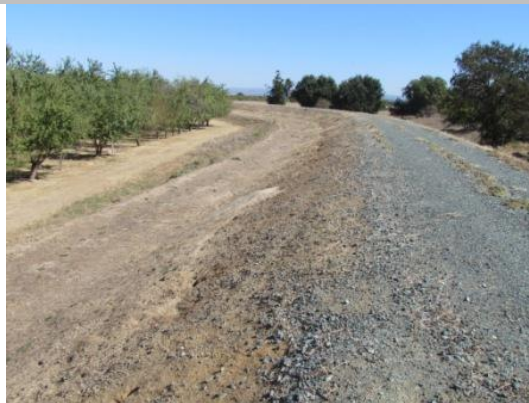
Photo 1 of 1 : mhoffman_s_20140401_286.jpg

LM Start	0.76	Rating **	U	Issue No.	1
LM End	0.76	Issue Type +	Ma	Location *	LS
Category	Earthen Levee			GPS Latitude/Longitude	
				Start	End
Item	Animal Control			38.996588 °	38.996588 °
				-121.424209 °	-121.424209 °
DWR ID	DWR_RD2103_02_f_2013_1				
Action/Comments					
Exterminate rodents and backfill and compact or grout burrows. Inspector Comments: Large squirrel hole in the landward slope of the levee.

This photo was taken from the levee crown facing east looking down the landward levee slope at a large squirrel hole.

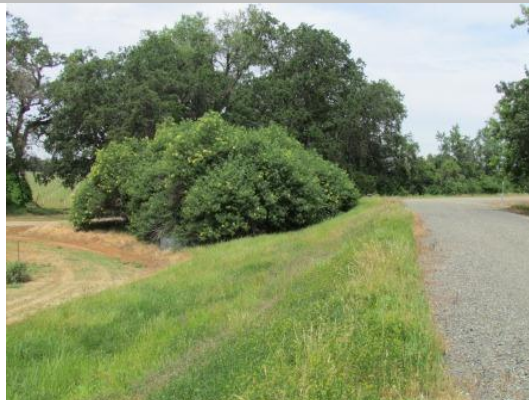
Photo 1 of 1 : mhoffman_s_20140428_485.jpg

LM Start	2.64	Rating **	M	Issue No.	7
LM End	2.64	Issue Type +	Ma	Location *	LS
Category	Earthen Levee			GPS Latitude/Longitude	
				Start	End
Item	Trim / Thin Trees			39.009077 °	39.009077 °
				-121.397318 °	-121.397318 °
DWR ID	DWR_RD2103_02_s_2013_7				
Action/Comments					
Trim trees to at least five feet above ground level. Inspector Comments: Large elderberry bush on L/S slope.

This photo was taken from the crown facing east looking down the landward levee slope at an Elderberry bush requiring trimming to maintain slope visibility. Spring 2014.
